RARITAN RIVER BASIN  
SOUTH BRANCH RARITAN RIVER  
HUNTERDON COUNTY  
NEW JERSEY

# LAKE SOLITUDE DAM NJ 00123

## PHASE 1 INSPECTION REPORT NATIONAL DAM SAFETY PROGRAM

May, 1979

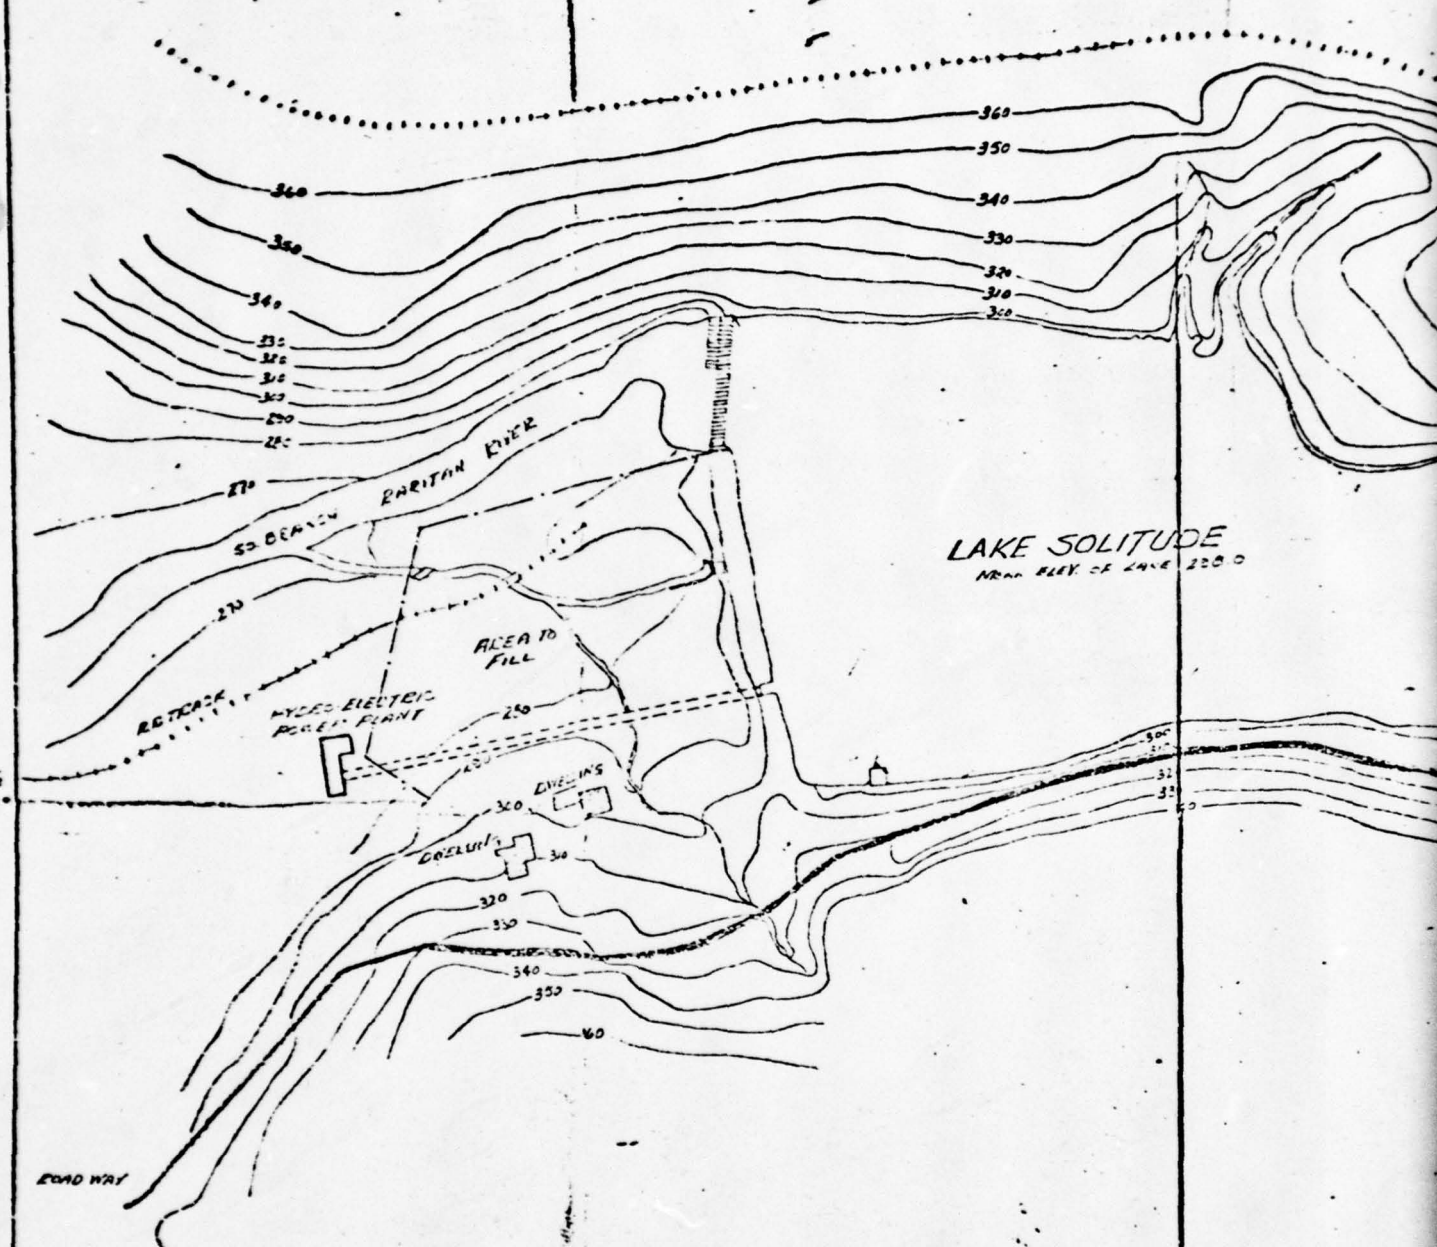
PLATE 2

natural and man-made portions is not known and there are no data regarding the design or construction of the embankment. Based on an old topographic survey (Plate 2), it would appear that the original man-made embankment extended the full 500 feet length of what is now the upstream side of a much wider embankment formed by subsequent dumping of waste material. An 8-inch diameter steel pipe is located in a concrete lined tunnel with a horseshoe cross section having a maximum width of 4 feet and a height of 3.3 feet, which passes through the right third of the embankment. It is assumed that the 8-inch pipe has an inlet somewhere in the reservoir, but neither the location of the inlet nor the purpose of the pipe is known. Flow is controlled by a gate valve at bottom of a concrete chamber in the embankment.

The drawings (Plate 2 and 3) show a railroad track terminating at the right end of the embankment. No information is available regarding the intent of this railroad line, but it may be assumed that it was used to transport fill for the embankment and/or construction materials for the masonry structure.

A concrete lined tunnel passes through the right third of the embankment and exits into a channel with masonry walls (Photo 5). This discharge channel is approximately 3 feet high by 5 feet wide and empties into the South Branch Raritan River downstream from the dam as shown on

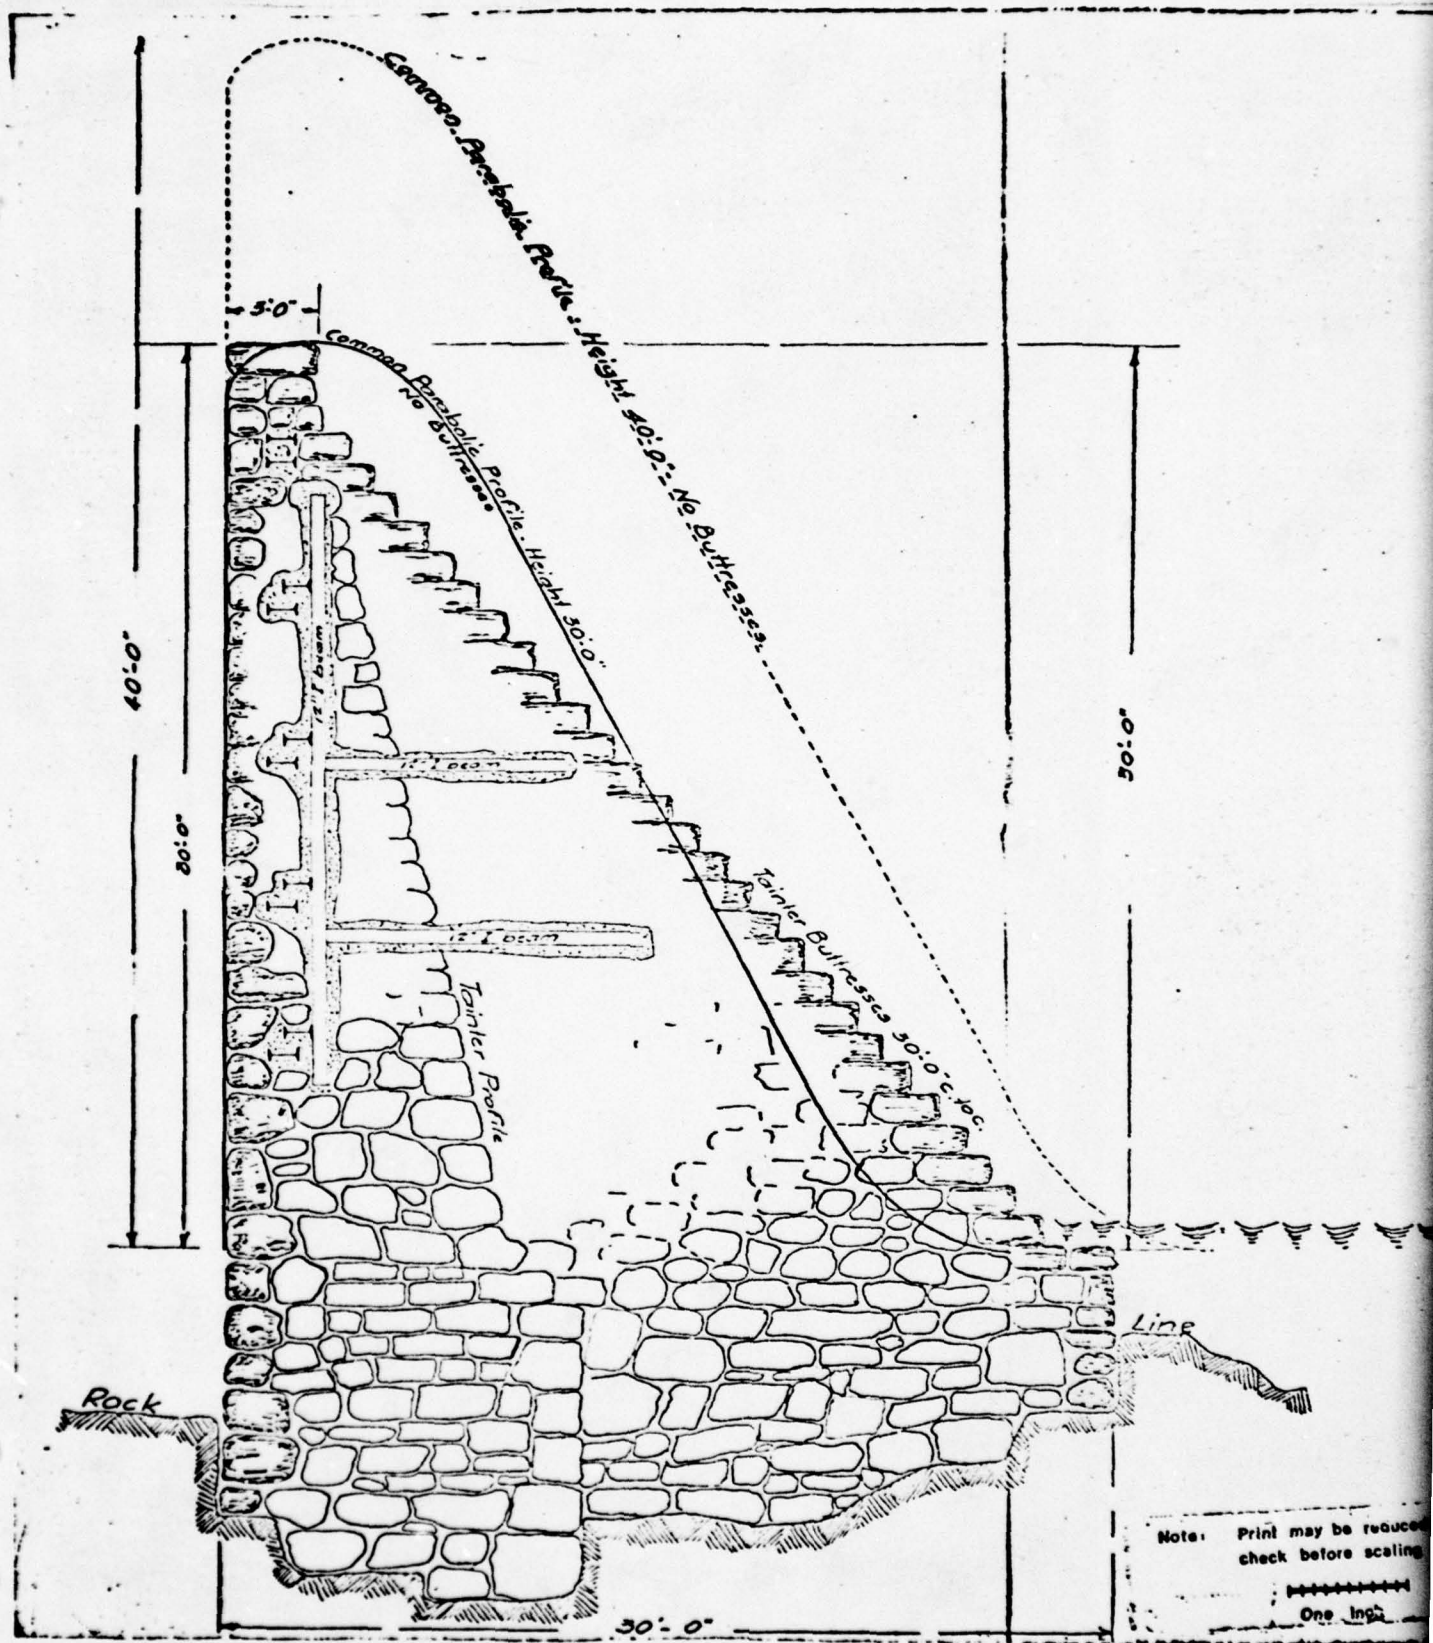
PLATE 5

The available drawings indicate that the masonry dam was designed by F. S. Tainter. The masonry dam is referred to as a steel compression dam with patent pending. The plans indicate that there were to be 6 buttresses on the downstream face of the dam (Plates 3 and 4); however, field observations revealed that there are only 4 buttresses. Thus the available plans apparently represent an earlier design. Plans indicate that the dam was designed with a skeleton of 12-inch steel I-beams set in concrete in the core of the dam (Plate 5).

ITEM	REMARKS
PLAN OF DAM	<p>(1) "Steel Compression Dam" plans &amp; section, 4 sheets, F. S. Tainter, Engineer, 1909.</p> <p>(2) "Steel Compression Dam, Solitude Development, Taylor Iron &amp; Steel Co., High Bridge, N.J." Plan and Elevation Stevens &amp; Co. Engineers, corrected Sept. 14, 1909. (Plates 3 and 4)</p>
REGIONAL VICINITY MAP	<p>(1) Contour map of a portion of the valley of south branch immediately above the plant of, The Taylor Iron &amp; Steel Company, High Bridge, New Jersey" E. A. Stevens &amp; Co., Engineers, March, 1909.</p> <p>(2) "Topography Surrounding Lake Solitude" drawing No. 1919-A, Taken from Dwg. No. 1402 by F. S. Tainter, C.E., dated October, 1906 - (Plate 2)</p>
CONSTRUCTION HISTORY	<p>Dams in New Jersey - Reference Data No. 24-57" dated 1/4/26 gives construction date of December 1909.</p>
TYPICAL SECTIONS OF DAM	<p>(1) See 'Plan of Dam'</p> <p>(2) 'Compression Dam Section Sheet', dated 10-12-38.</p> <p>(3) Study of Profiles of Spillway at Solitude Lake; Dwg. No. 19273, dated 11-8-18. (Plate 5)</p>

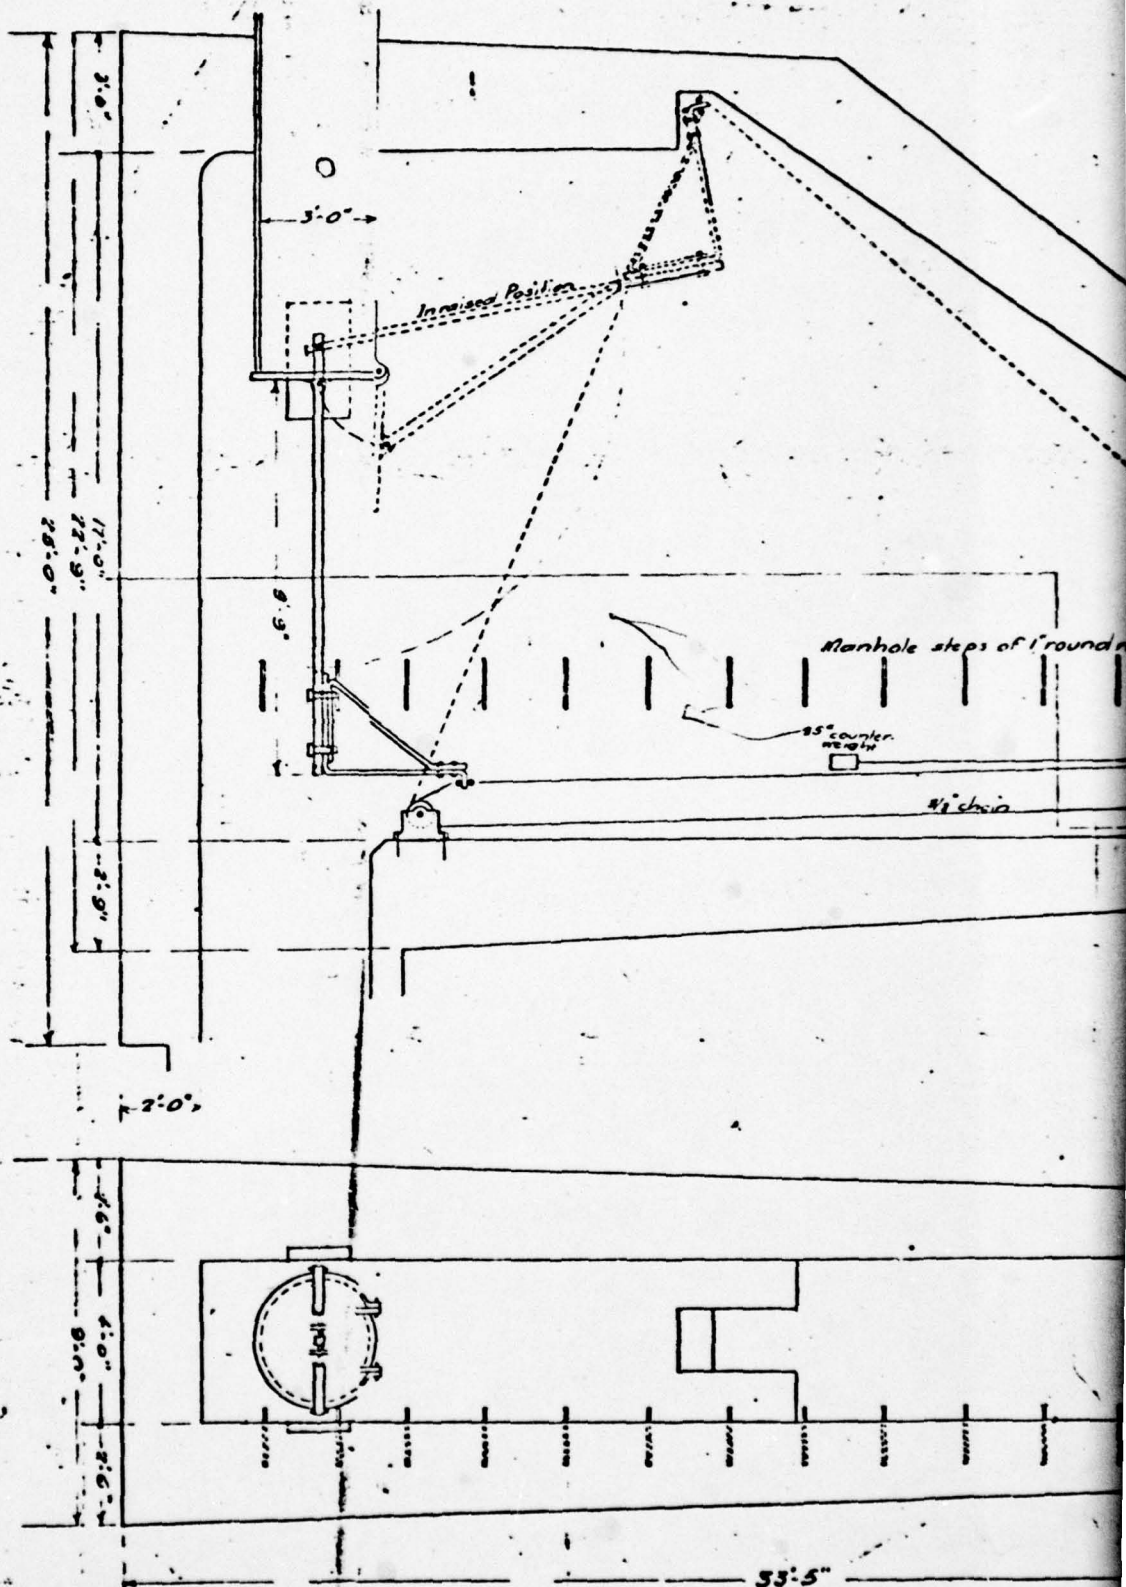
PLATE 6

A 3-foot diameter outlet passes through the right third of the masonry dam. The circular flap gate is controlled by pullies and a lever arm and is operated manually by two crank winches located at the crest of the dam (Plate 6).

The outlet through the base of the masonry dam is shown on Plate 6. The controls to this outlet are located on the crest of the dam (Photo 1). This outlet, including the gate controls, were inaccessible for inspection due to water passing over the dam. Any former access devices or structures, such as cable rigging or a bridge, have been destroyed.

HYDROLOGIC/HYDRAULIC DATA	See 'Typical Section of Dam' item 3.
OUTLETS - PLAN	See 'Plan of Dam'
- DETAILS - CONSTRAINTS - DISCHARGE RATINGS	Section and operating equipment shown on 'Sluice at Dam' Dwg. No. 19169, dated 7/16/18. (Plate 6) None known Not Available.
RAINFALL/RESERVOIR RECORDS	None
